**‘South Block’
County Hall
Racecourse Lane
Northallerton
DL7 8AD**

County Hall Redevelopment

Maintenance Access to Roof Void Services

**Design and Access Statement &
Statement of Significance and
Impact**

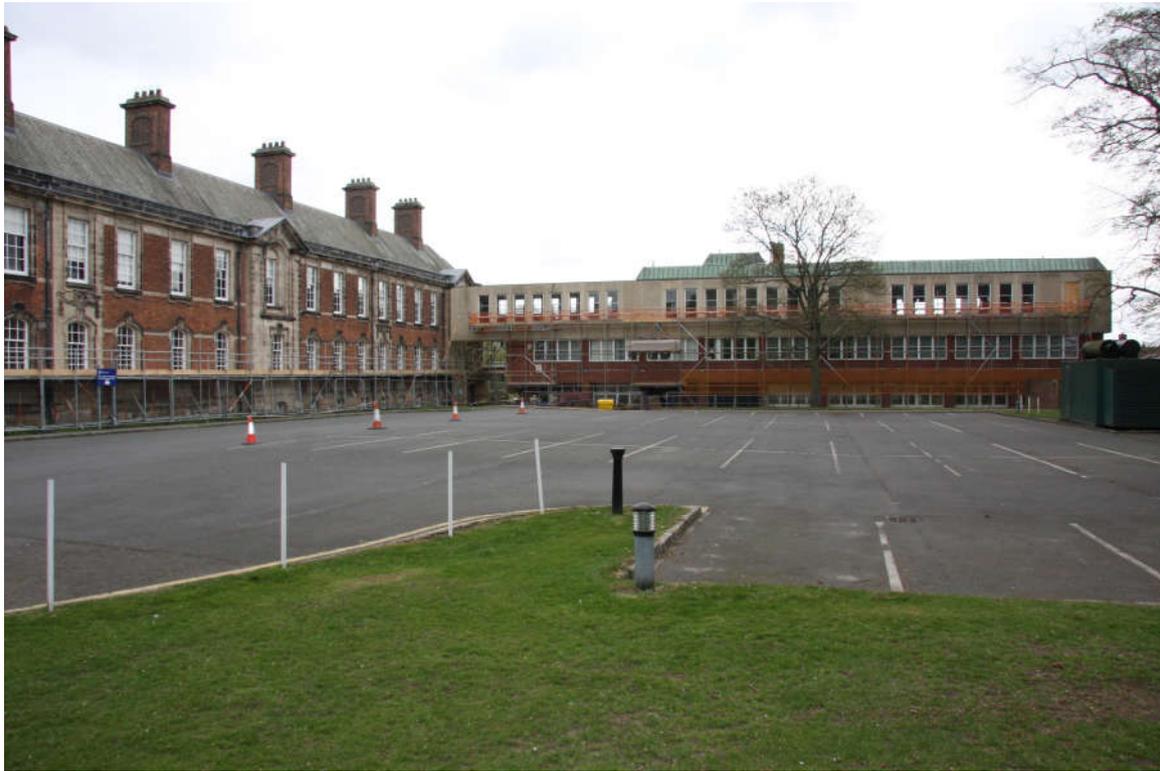
Photo 1 – Brierley Building (left), 'South Block', North East facing elevation (right)

The external appearance of the building (photos 1 & 2) is its most significant feature having been designed to echo the appearance of the Brierley Building, albeit using the materials and architectural style contemporary to its period of construction. The green copper covered mansard roof resembles the green Westmorland slate of the Brierley Building with the buff coloured concrete wall panels and red brick of 'South Block' being of similar colour and texture to the redbrick and sandstone ashlar of the Brierley Building. The vertical aluminium sliding sash windows are the 1970's equivalent of the earlier timber sliding sashes chosen by Walter Brierley.

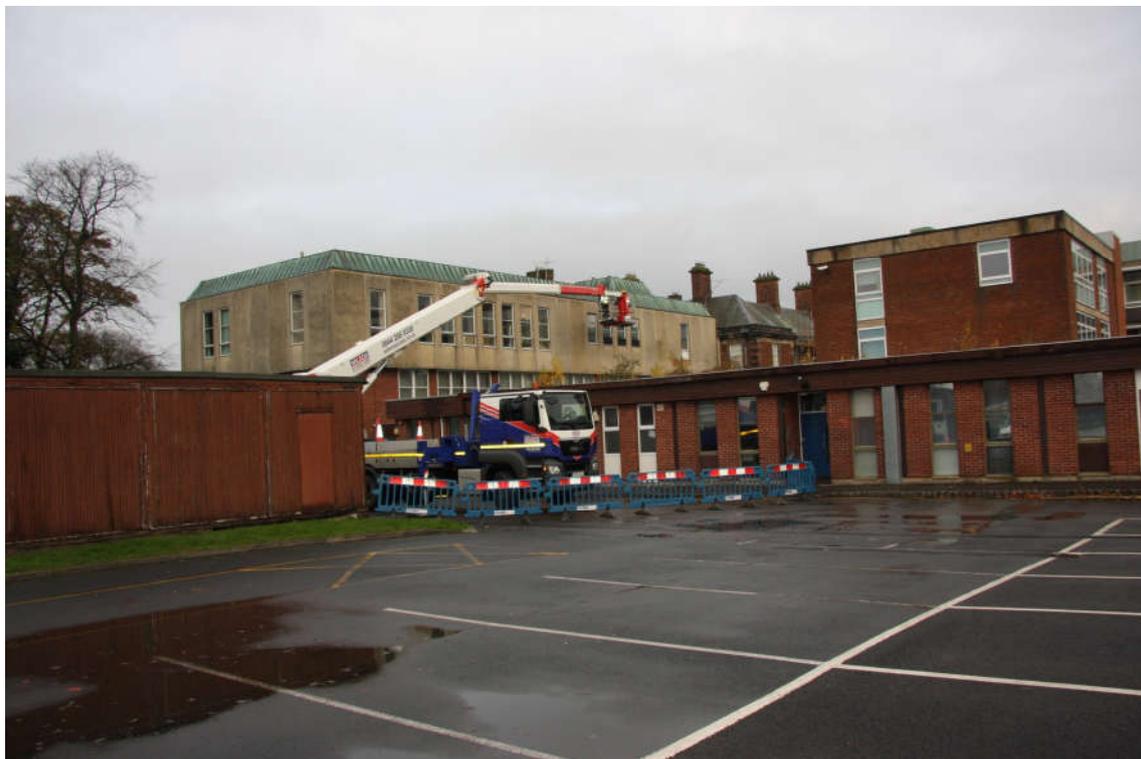
Photo 2 – 'South Block', South East facing elevation (centre)

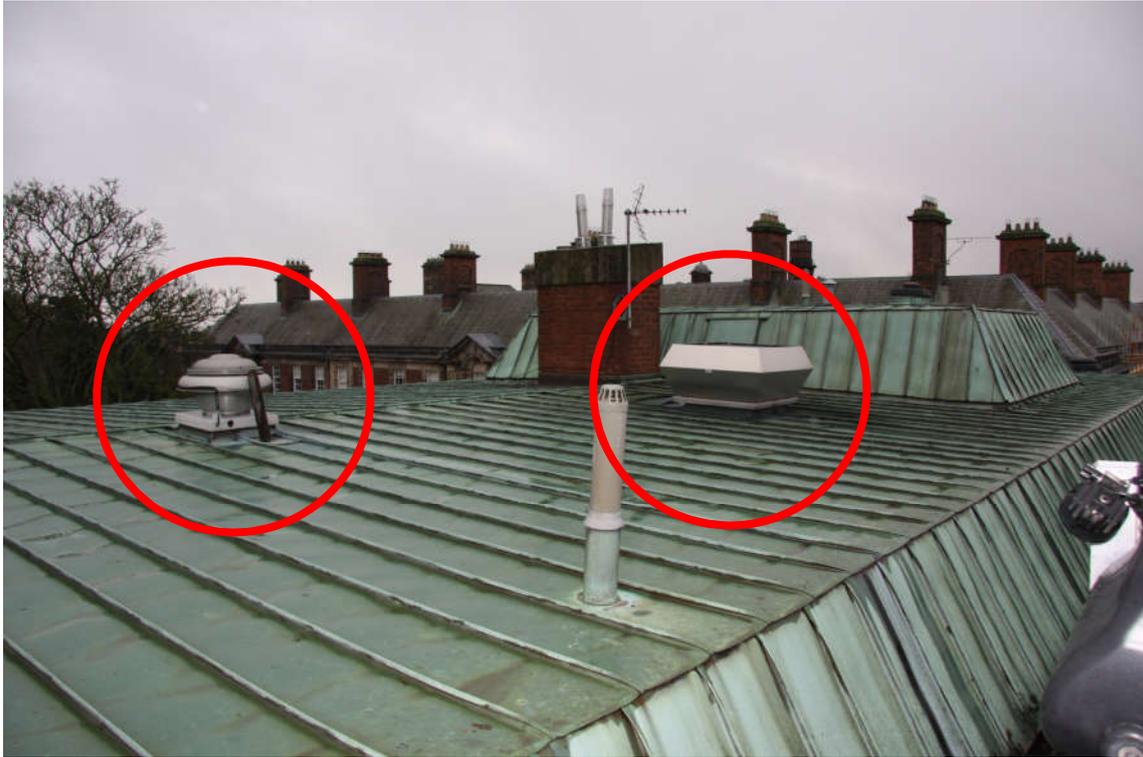
Photo 3 – ‘South Block’ mansard roof. Circles indicate fans to be replaced with cowls.

There are two extract fans on the roof serving the second floor restaurant kitchen (Photo 3), which require regular maintenance. The extract fans are reached by climbing out on to the mansard roof from a hatch in the Tank Room. There are no guardrails or fall protection measures on the roof.

The existing extract fans on the roof will be replaced by new fans installed within the roof void thereby negating the need for maintenance access onto the roof. The existing fans will be removed and replaced by green epoxy powder coated cowls, which do not require maintenance and will have minimal visual impact as the green colour will be chosen to closely match the copper roof colour. The existing modern ventilation ductwork within the roof void will be altered to suit.

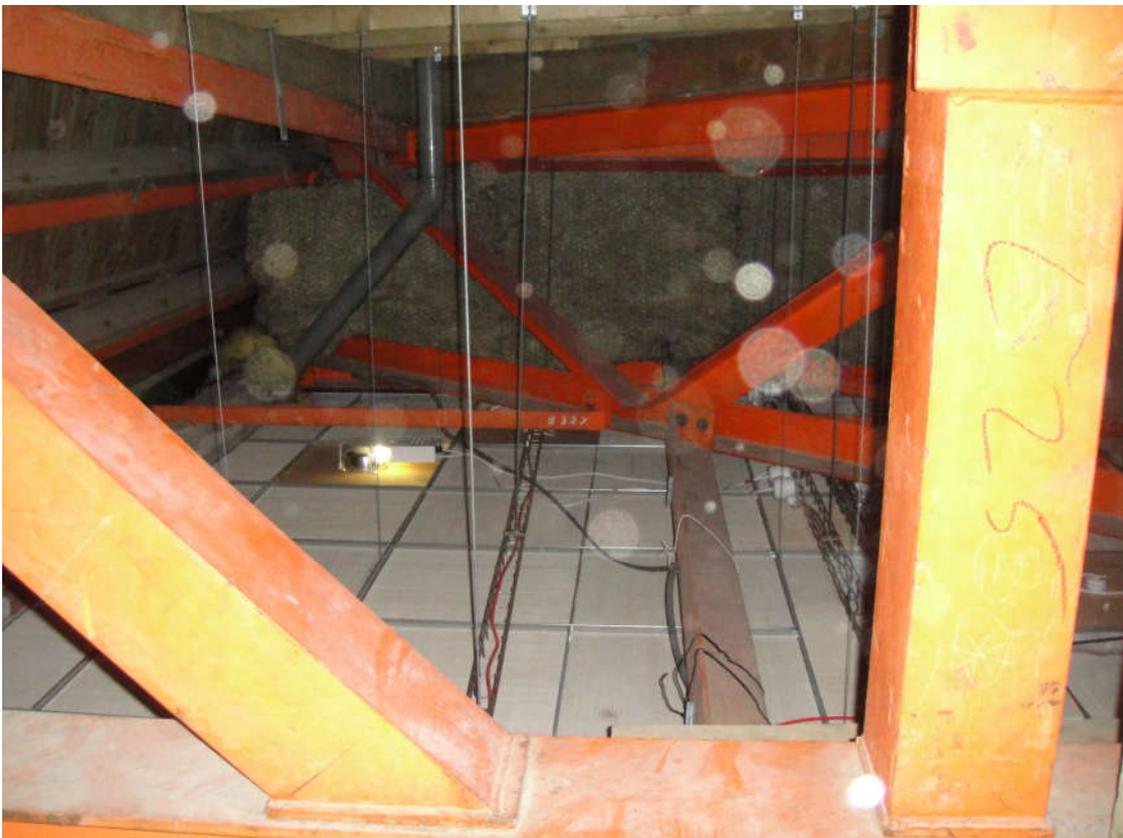
Photo 4 – Typical view within ‘South Block’ roof void.

There is ventilation ductwork in the roof void, which requires regular inspection. The headroom in the roof void is restricted and there are a number of trusses and other obstacles to negotiate (Photo 4). The roof void has been boarded out in areas with timber bearers and plywood boarding, which is at different heights creating a trip hazard, and there are no barriers to prevent people or tools from falling through the adjacent modular suspended ceilings. There is no lighting, emergency lighting or fire alarm system in the roof void.

The existing timber bearers and plywood in the roof void will be removed and the roof void will be boarded out with new plywood on treated timber joists secured to the bottom angles of the existing girder roof trusses. An assessment of the existing structure and the loads that will be applied upon it by the installation of and use of the proposed walkways has been assessed by a Structural Engineer. The installation will not cause any damage to the existing building structure through the application of excessive loads. The boarding will all be at the same level to prevent tripping and will cover all areas where people require access, thereby removing the risk of people and objects falling through the modern suspended ceilings. The existing plywood fire doors will be altered to suit the new floor level.

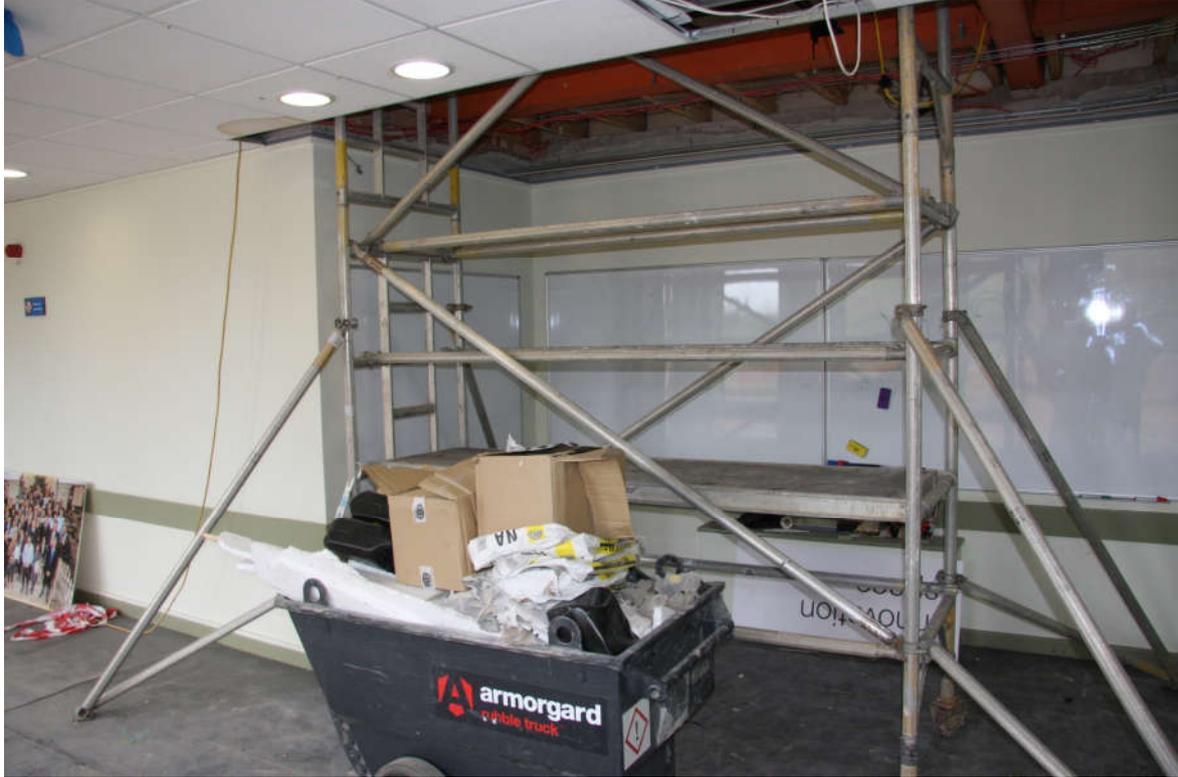
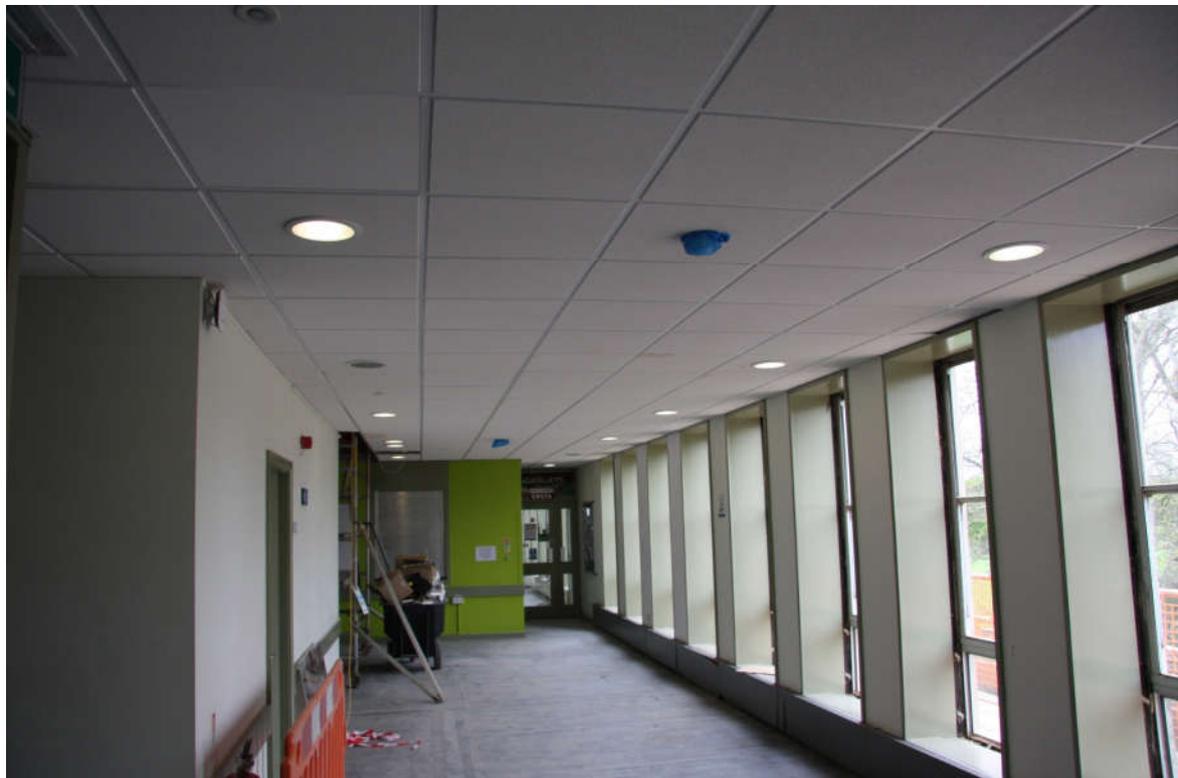
Photo 5 – The scaffold tower is located in the proposed drop down staircase position.

Photo 6 – The scaffold tower is located in the proposed drop down staircase position

All the proposed internal work are to take place within the roof void and to an area of the second floor ceiling where a drop down staircase will be installed (Photos 5 & 6). The modern exposed grid mineral fibre tiled ceiling is suspended from the building structure within the roof void above. The ceiling has no historic significance and was probably installed circa 2000.
